An Archeological Curation-Needs Assessment for the U.S. Navy, Engineering Field Activities, West and Northwest, Naval Facilities Engineering Command

Archaeological Curation-Needs Assessment
Technical Report No. 9

Amy E. Halpin and Kelly L. Holland

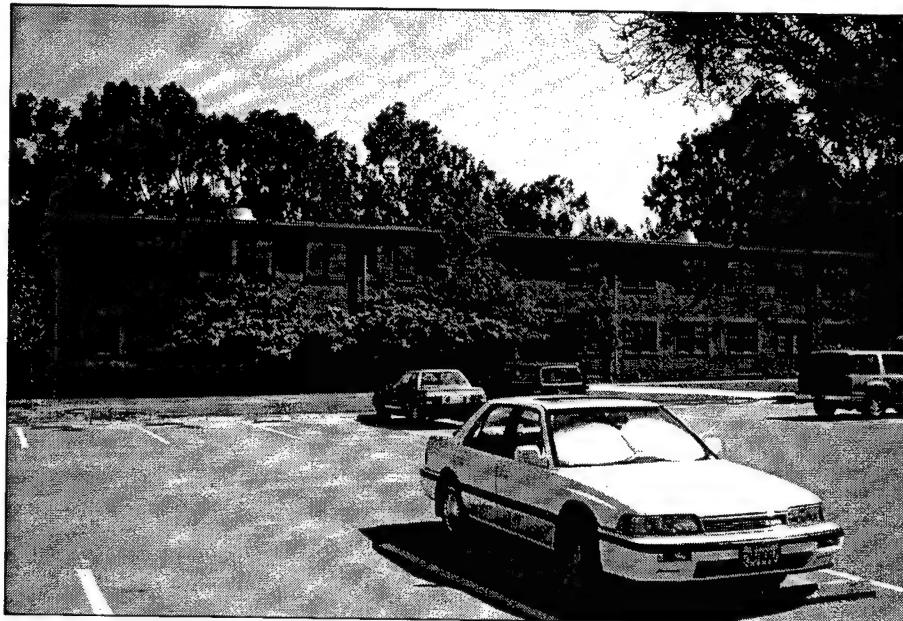
Building 105 (Figure 1) is a wood-frame structure with a concrete foundation and stucco exterior walls. The tar-and-gravel roof was last

Figure 1. Exterior view of Building 105, which houses the EFA West offices.

replaced in 1976. Cracks in the foundation were noted; however, no leaks have been reported. The floor is wood, covered with asbestos tiles and carpet. Interior walls are plasterboard. The ceiling comprises a double layer of suspended acoustical tiles. Newer tiles were placed over the old ceiling. Rows of double-hung windows are on all four sides of the building. Windows have venetian blinds. There is no evidence that indicates water has leaked through the windows. Support utilities/rooms include electric heat, rest rooms, and telephones. The original plumbing was updated in the 1970s and again in 1984. The electricity and heating have also been updated. Overhead pipes are present in the report storage areas, but are not exposed. Water damage from a leak in the second-floor rest room down the hall was noted on the ceiling tiles. Renovations to the building currently are underway.

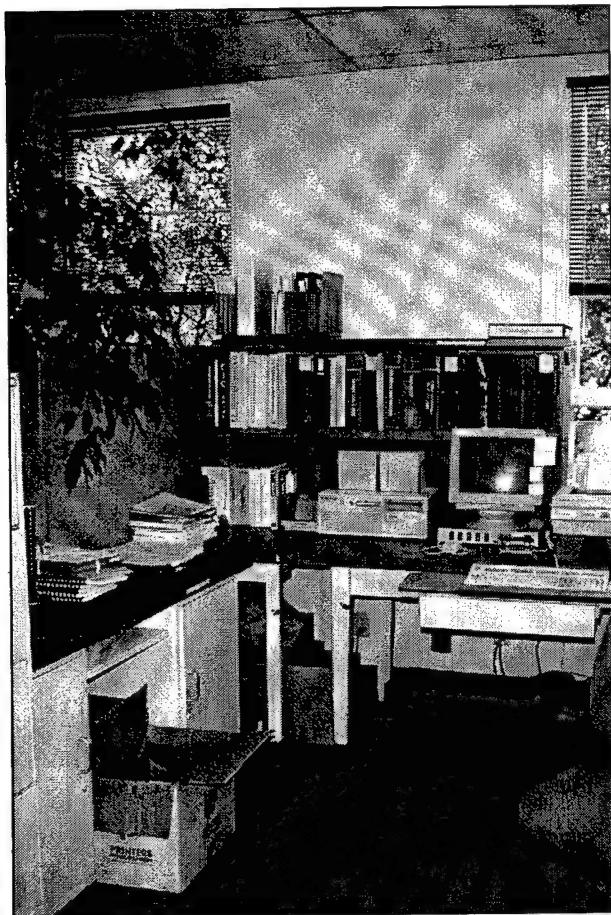
Figure 2. Shelves in the archeologist's office where archeological documentation is stored for EFA West.

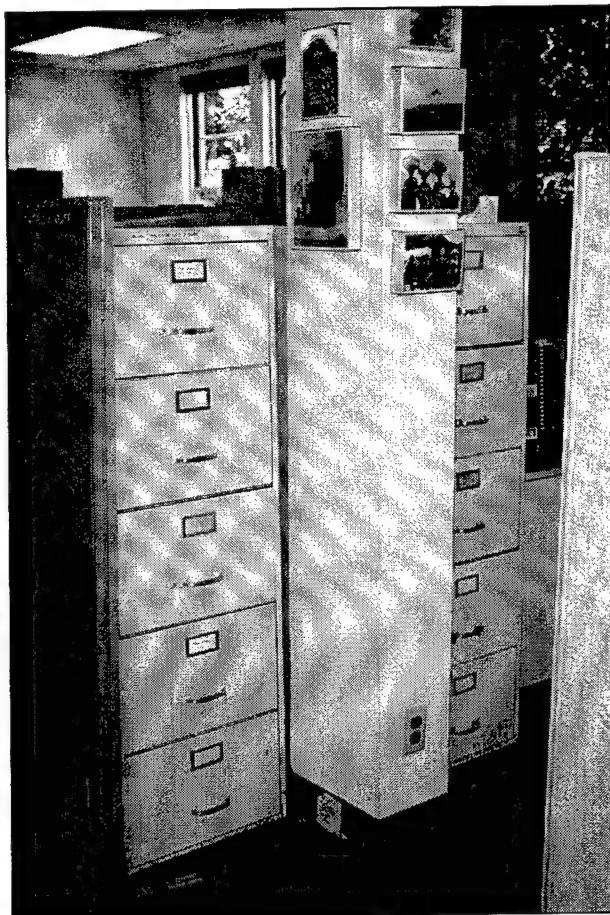
Figure 3. File cabinets in the archeologist's office at EFA West where documentation is stored.

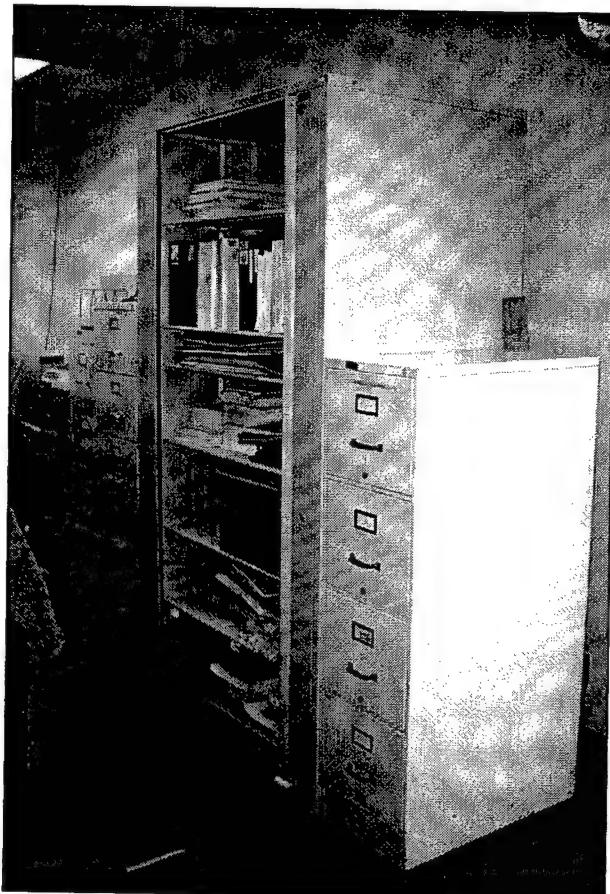
drawer, unlabeled filing cabinets and a lateral filing cabinet (Figure 4). Master plans are located in a second-floor library that was not assessed. Storage for both offices is at 100-percent capacity. File folders are acidic, and contaminants are present on the original documentation.

Figure 4. Metal storage units in the CRPM's office at EFA West house associated records.

1. Install an HVAC system and a dust-filtration system.
2. Install a sprinkler system, in conjunction with heat sensors or smoke detectors.
3. Develop and implement an emergency-management plan.
4. Employ an integrated pest-management system.
5. Dedicate more space for the proper storage of record collections.

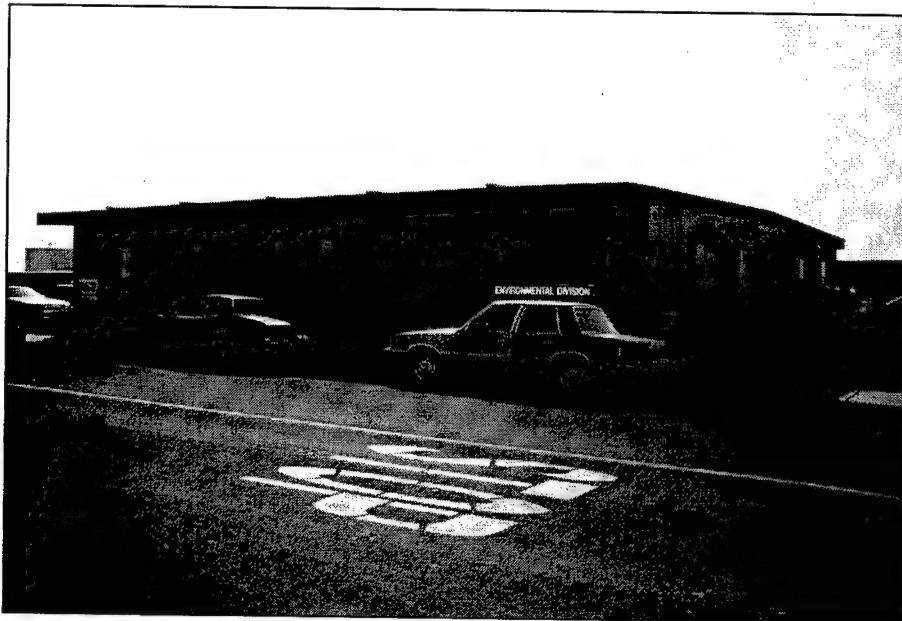
Figure 6. Exterior view of Building TR10073, the Environmental Division offices building at NAWS Point Mugu.

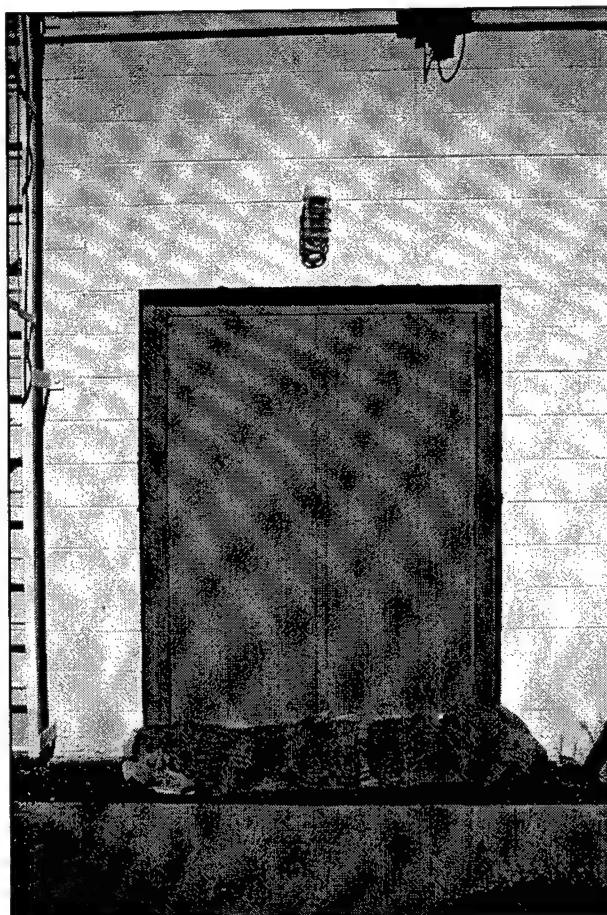
There is no integrated pest-management plan for this repository. Plans are being developed

Figure 7. Exterior door on Building 156.

for a control program that will include use of a pest-management contractor who will visit on an as-yet-undetermined schedule. Some pests noted by the previous occupants of the building were mice, pill bugs, and spiders. During our assessment we noted pill bugs in the hallway and various other bugs transported from the previous facility, including silverfish. In the former facility, pest-management methods included mouse traps and “no-pest strips” for monitoring.

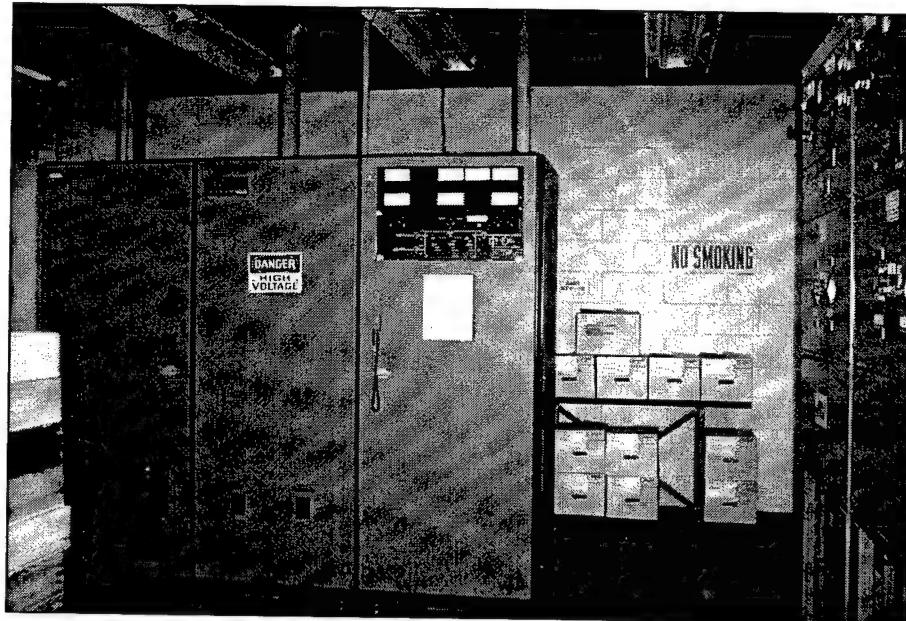
Figure 8. Electrical equipment located near artifacts in the collections storage room in Building 156.

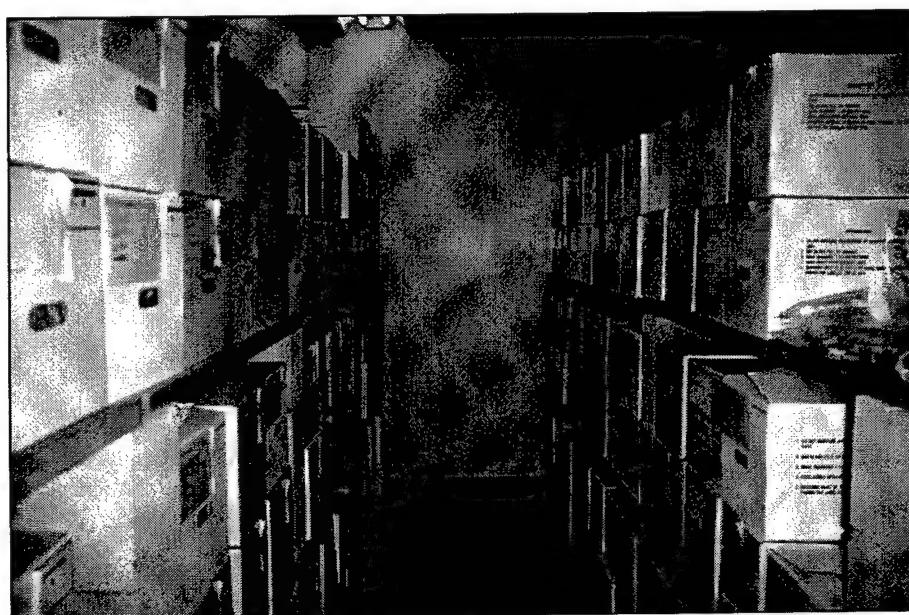
Figure 10. Primary storage containers in the collections storage room in Building 156.

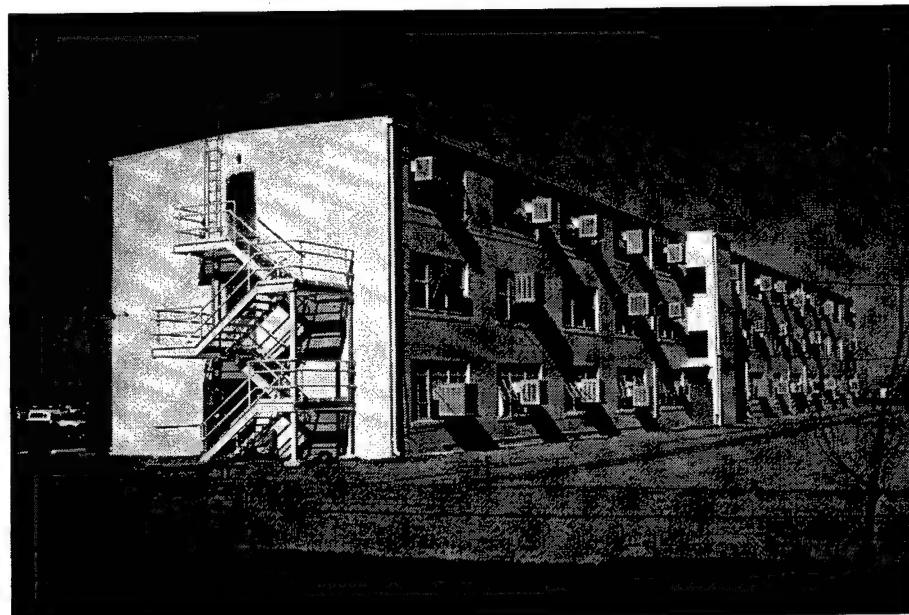
Building 307 is structurally solid and does not show any sign of cracks or leaks. It is a three-story, aboveground, concrete-block building (Figure 12). The windows on the first and third floors are original, with steel frames, but the windows on the second floor were replaced within the last 10 years and now have aluminum frames. There is no evidence of water leakage through any of the windows. They are approximately two and one-half feet wide by three feet high and are shaded with metal blinds.

Figure 12. Exterior view of Building 307 at NAS Fallon.

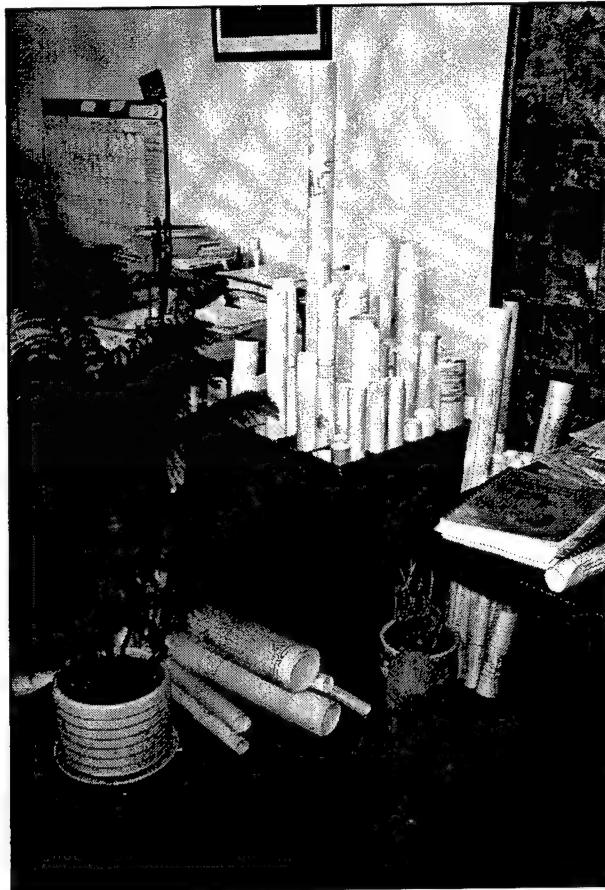
Copies of topographic maps and original blue-line maps are folded and stored in a lateral file drawer with the other associated documentation. Other NAS Fallon maps are rolled and placed either on end in a varnished wooden map box next to Jones's desk or on the ground next to the map box (Figure 15).

Figure 15. NAS Fallon maps from archeological projects are stored upright in a wooden storage box; some are stored on the floor.

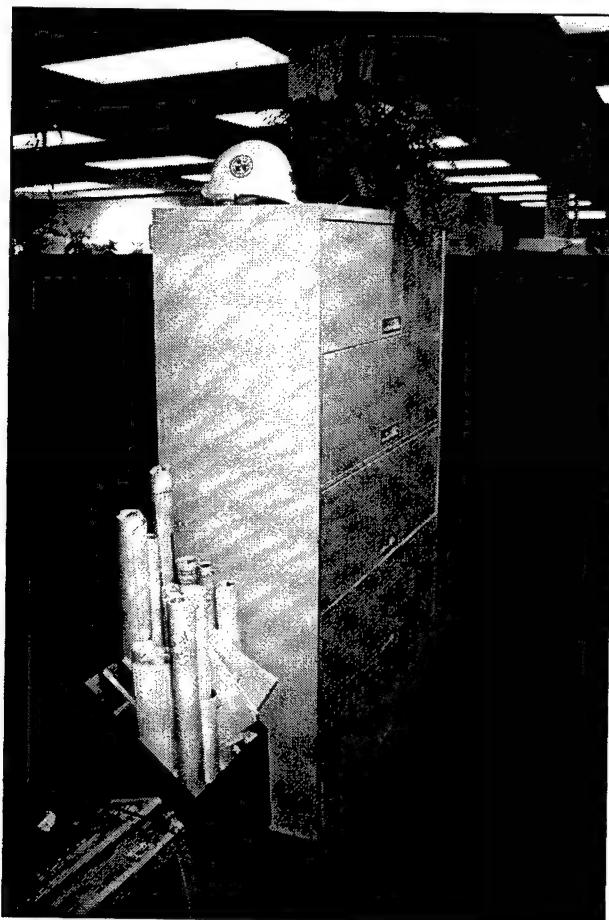
Records are stored within the office spaces of several employees at EFA Northwest. Associated archeological documentation has never been inventoried. It is accessible to anyone with a legitimate request to see the documentation and is stored in working files kept in filing cabinets (Figure 17). Documentation is filed by project and is controlled by the managers of each project.

Figure 17. A lateral vertical file cabinet is used for the storage of associated records at EFA Northwest.

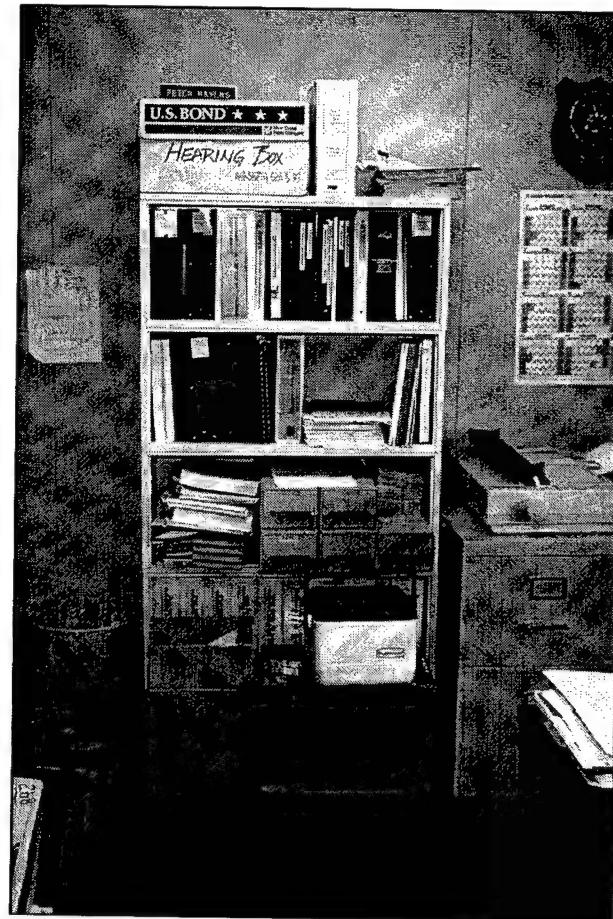
Havens's working files are located in a letter-size, four-drawer metal file cabinet. Older project files are stored in a five-drawer lateral file cabinet (42 x 18 x 64 inches). An identical lateral file cabinet contains most of his reports. Both file cabinets are in a central location in the EFA Northwest offices. Some of the reports are stored in a metal shelving unit by Havens's desk (Figure 18).

Figure 18. A metal shelving unit is used for storage of associated records at EFA Northwest.

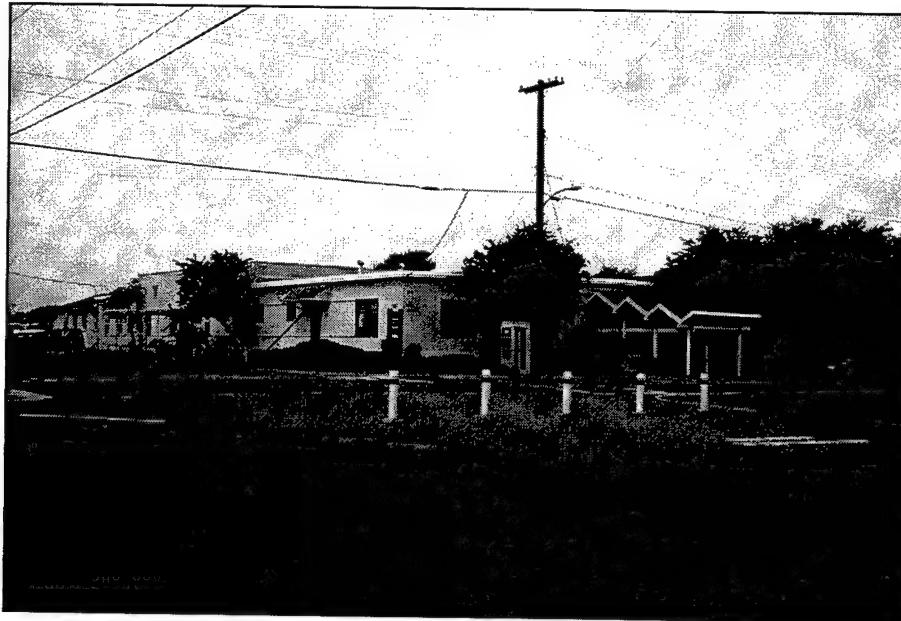
Figure 19. Exterior view of Building 119 on NAS Whidbey Island.

Building 119 is a one-story, aboveground structure with a combination foundation (see Figure 19). Half of the building rests on piers and posts; the other half is composed of poured concrete with posts. The exterior walls have wood studs and asbestos panels. The roof, made of asphalt and tar shingles, is original to the structure. Repairs have been made on an as-needed basis. The office building is structurally solid, with no signs of cracks in the foundation or leaks in the roof.

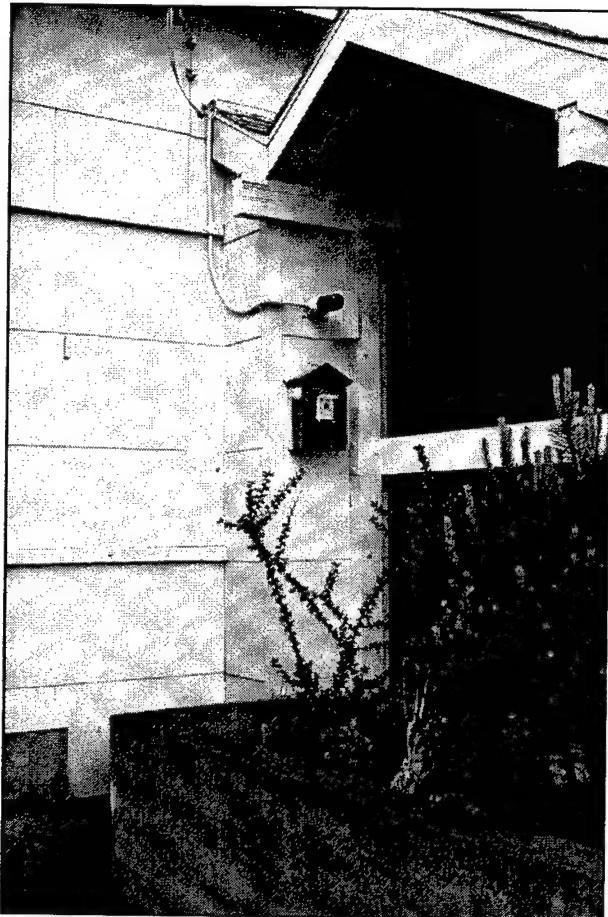
Figure 20. A manual fire alarm is located near an exterior door of Building 119.

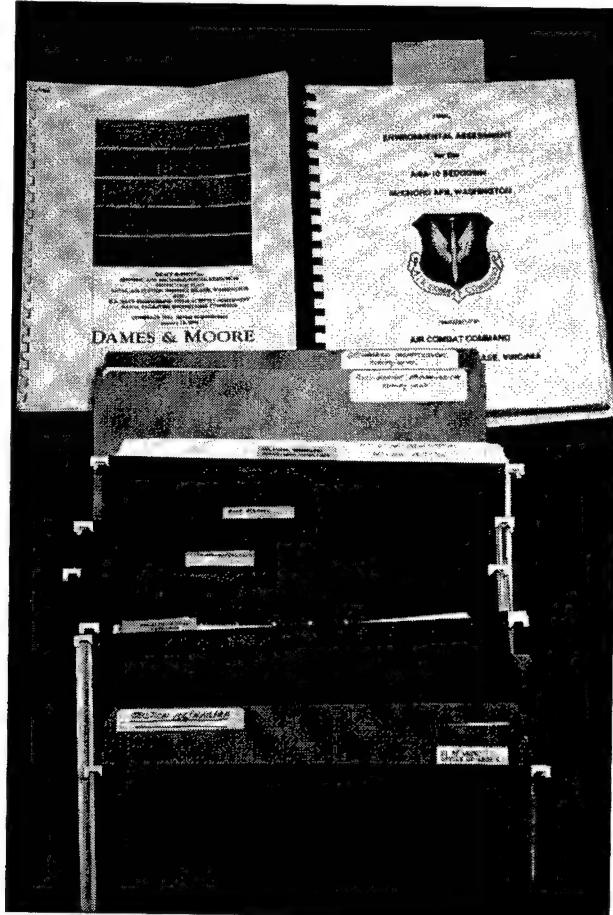
Paper records include administrative records, correspondence, background information on legislation, copies of site forms, draft statements of work, newspaper articles, regulations, copies of notes referring to Boardman Bombing Range, draft scopes of work, and a coroner's report (Figure 21). No duplicates of associated documentation have been made. Records are stored in acidic file folders. Labels on the folders consist of plastic tabs containing acidic-paper inserts

Figure 21. Associated records for NAS Whidbey Island.

that have been written on in ink. Contaminants are present (e.g., paper clips and staples). There is no finding aid for the documentation collection.

Reports are stored with the other paper records, in acidic file folders in the filing cabinet (see Figure 21). Reports present include an environmental assessment of the Boardman Bombing Range, and several reports for NAS Whidbey Island. Reports are bound with nonarchival materials. Copies of the reports are on file at EFA Northwest. A letter report regarding the discovery of human remains on NAS Whidbey Island is also included in the records collection.

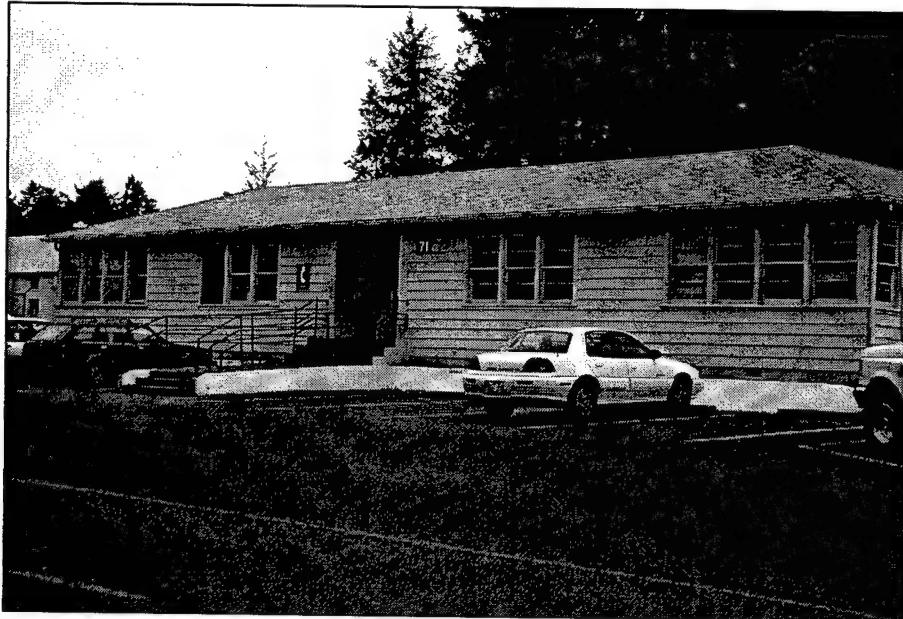
Figure 22. Exterior view of WPNSUPFACSBDET Port Hadlock Building 71.

Building 71 is a one-floor, aboveground, 4,610-ft² structure with a solid concrete foundation. It is wood framed, with wood-sided exterior walls. The roof was replaced in 1982 with one constructed of a composite material. WPNSUPFACSBDET Port Hadlock has a standard policy to replace roofs every 20 years. Building 71 is rated as structurally "adequate" by structural engineers, and there were no signs of cracks or leaks. With the exception of the new roof, and painting, there have been no external or internal renovations of the building (Figure 22).

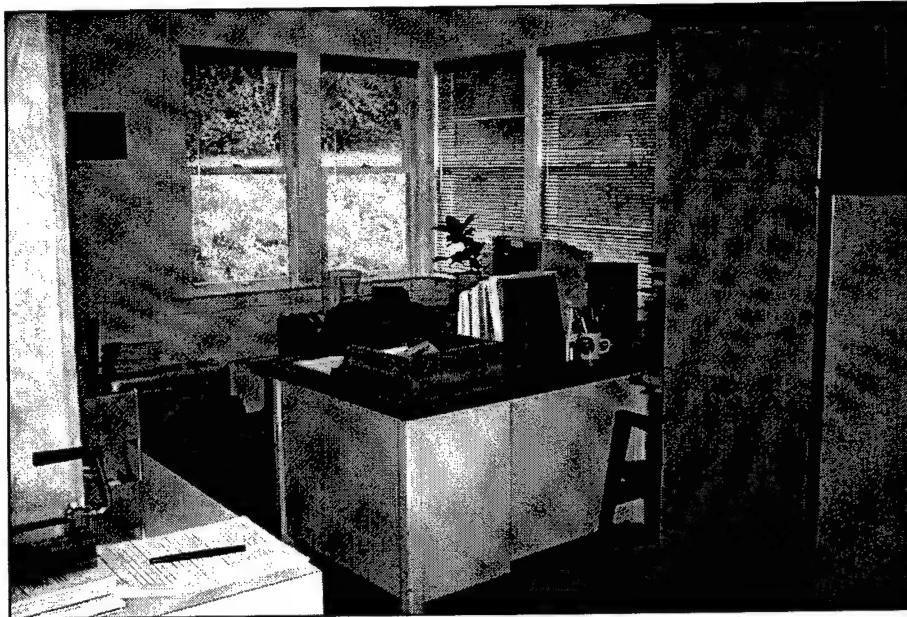
Archeological documentation is stored in the biologist's 225-ft² office (Figure 23). Her office is located in a large room that is shared with at least four other offices. The concrete floor is tiled, and the ceiling has painted wooden panels nailed to wood beams. Interior office dividers include file cabinets, shelves, and one three-quarter

Figure 23. Public Works office in WPNSUPFACSBDET Port Hadlock Building 71.

partition. The four office windows, two facing east and two facing south, have venetian blinds. Asbestos is present in the walls, and possibly around the pipes as insulation. One interior door on the west wall is paneled with wood; it leads from the large, open, office area into a common hallway. Lighting in the offices is provided by natural light through windows and from fluorescent lights; none of these light sources has ultraviolet filters.

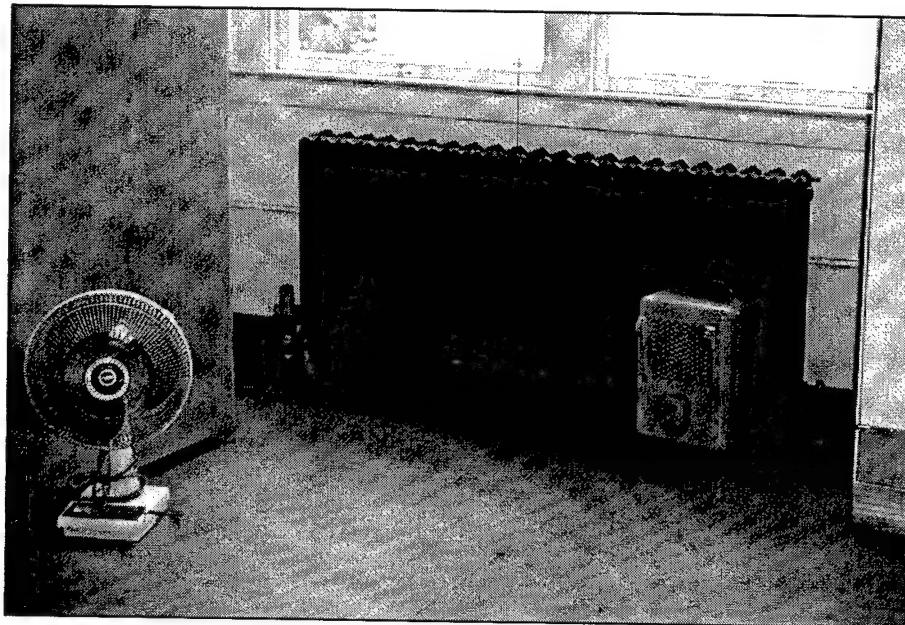
The building is heated by hot-water radiators that are controlled by a thermostat (Figure 24). The boiler used for steam heat is new, and is not located within this building. Space heaters and fans are present in all the offices. No air-conditioning or humidity controls have been installed in Building 71. Dust filters are not present on any of the heating units. Dust does not appear to be a problem, but mildew is. The building is

Figure 24. Heat in Building 71 at WPNSUPFACSBDET Port Hadlock is provided by hot-water heaters.

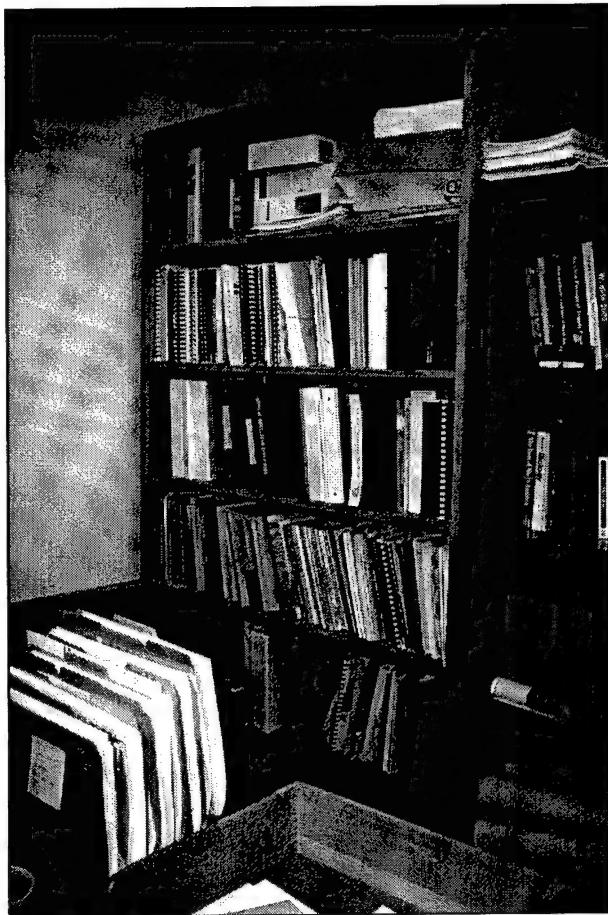
Approximately 1 linear foot of archeological documentation is located in the biologist's files. One file cabinet drawer and 6 inches of wooden shelving are used for records storage (Figures 25 and 26). Records are kept in three legal-size, acidic, accordion-type file folders. Files labeled "Archaeological Documents" are kept in a file cabinet drawer. Expandable files and reports, including reports of negative findings, are organized on a shelf. Some discoloration and damage was noted on at least one folder. One file was labeled "Historical files 5720," typed on a paper label. Another had been labeled directly with a

Figure 26. Wooden shelves in Building 71 at WPNSUPFACSBDET Port Hadlock store approximately 6 linear inches of associated records.

7. Duplicate all paper records on acid-free paper, and place the records in acid-free folders labeled with indelible ink. Place all folders in acid-free cardboard boxes and apply adhesive polyethylene label holders, with acid-free inserts, to the boxes.
8. Store the duplicate copies of associated documentation in a separate location that is fireproof and secure.
9. Arrange documentation according to modern archival procedures and create a finding aid for the documentation collection.
10. Provide funding to hire an individual, with an appropriate background in archeology, to assume responsibility over the archeological activities on WPNSUPFACSBDET Port Hadlock.
11. Establish procedures and protocols for the management of archeological documentation.

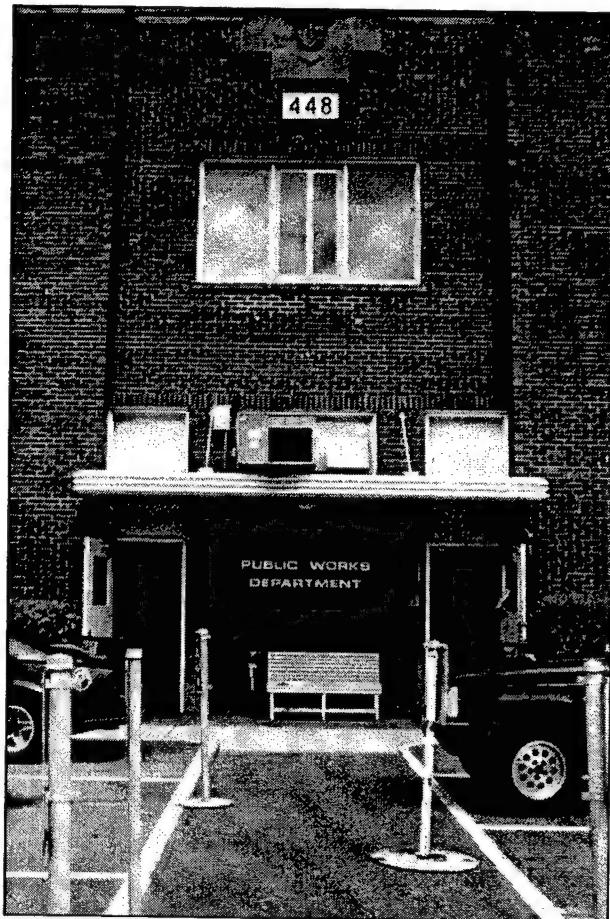
Archeological and historical documents are located in Building 448, the Public Works Office for NAVSHIYPD Puget Sound (Figure 27). The facility encompasses 55,702 ft². Activity areas within the facility include a receiving/loading dock, a materials/supplies storage area, a records storage area, offices, a mechanical/utility

Figure 27. Exterior view of Building 448, which houses the Public Works Department on NAVSHIPYD Puget Sound.

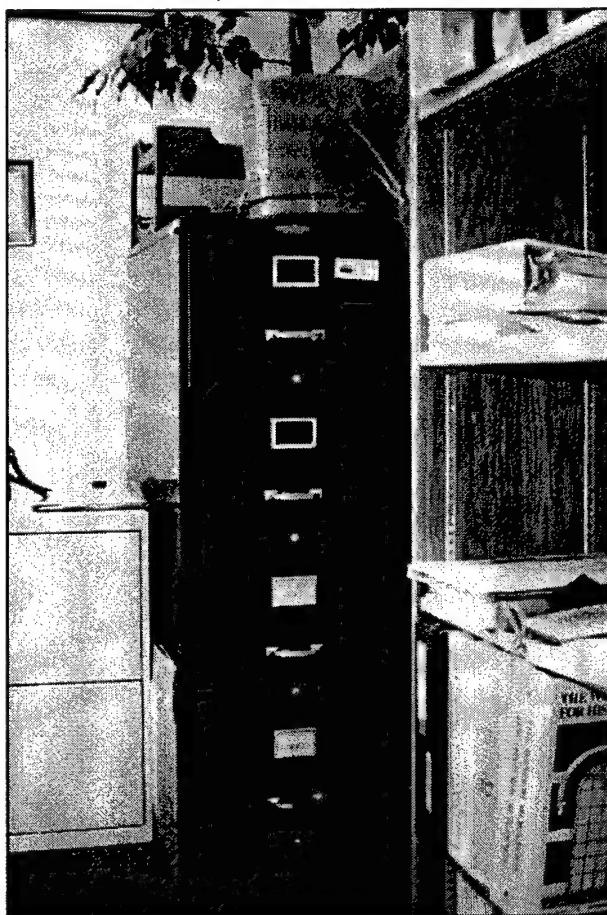
Figure 28. Associated records are stored in this metal file cabinet in Building 448.

Employees and visitors must enter the shipyard under tight security, and be escorted at all times while on base. This building is located within the nuclear materials area, which requires an identification badge and a check of personal identification for entry. Security cameras monitor the outside of the building. There has been no evidence of past unauthorized entry of the facility. Security measures within the office include locks on the windows. The filing cabinets, where associated documentation is stored, are not locked.

Records are stored in one acidic file folder kept in a legal-size metal filing cabinet located within Khadem's office area (Figure 28). The area is entirely office space and measures approximately 120 ft². There were no photographic records, maps and oversized documents, audio-visual records, or machine-readable records associated with any archeological work on NAVSHIPYD Puget Sound.

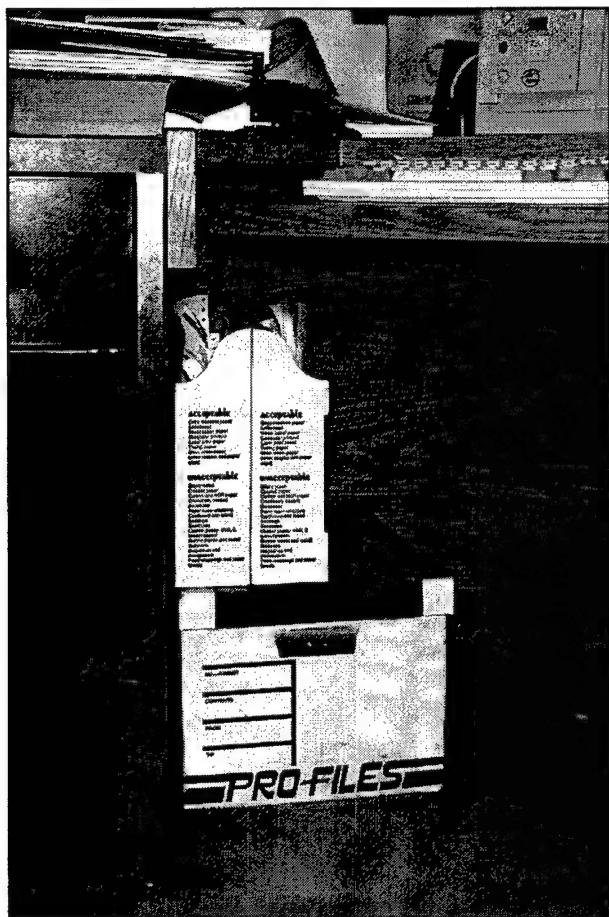
Figure 31. Historical-period artifacts are stored in an acidic-cardboard box under a desk in the forester's office.

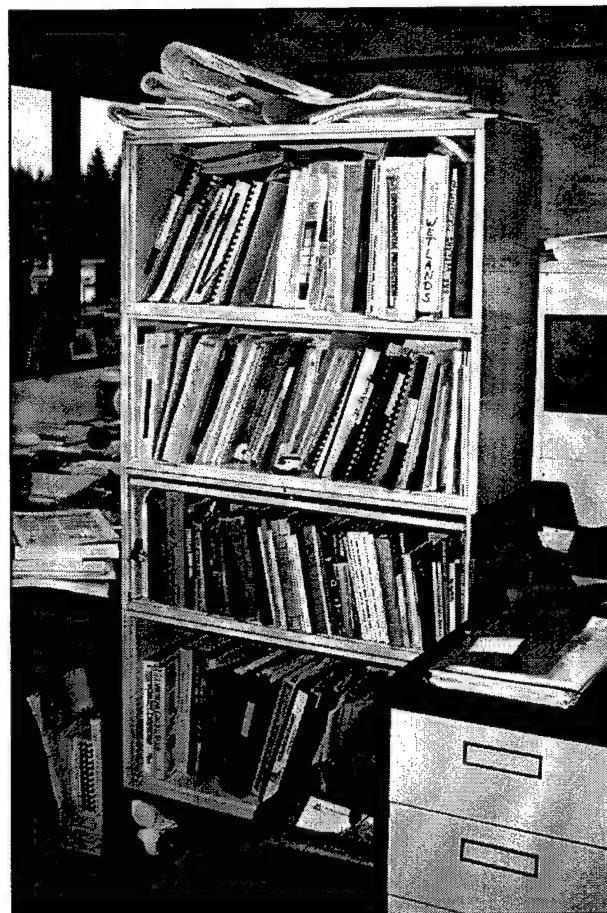
Records are stored in three locations within one room. Field notes, photographic records, and report copies are stored in one container, an inventory is stored with the artifact collections, and the report is stored on a book shelf (Figure 32).

Figure 32. Archeological survey reports for SUBASE Bangor are stored on metal bookshelves in the forester's office.

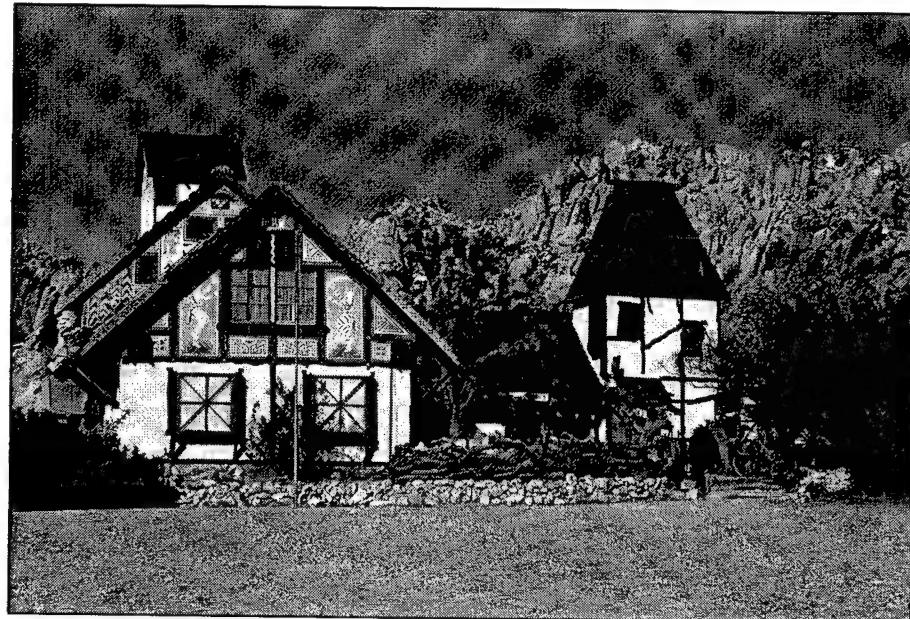
Figure 36. Exterior view of the Antelope Valley Indian Museum.

wood planks and boulders. The roof, replaced in 1985–1986, and ceiling display evidence of water damage. Some of the walls were replaced in the 1940s by Oliver, but some walls and supporting beams remain unstable. Structural engineers who evaluated the condition of the museum stated that a complete rehabilitation is necessary in order to maintain the historical integrity of the building.

The plumbing and electrical systems in Repository 1 were upgraded in the early 1940s. No significant improvements or renovations have been made to the utility systems since then. The structure’s windows and doors (solid wood) are in wooden frames and are original to the structure. Evidence of air and water leakage was noted by the St. Louis District team. The windows are of various sizes and do not have shades or blinds. Windows on the south side of the museum have ultraviolet-protectant film on them.

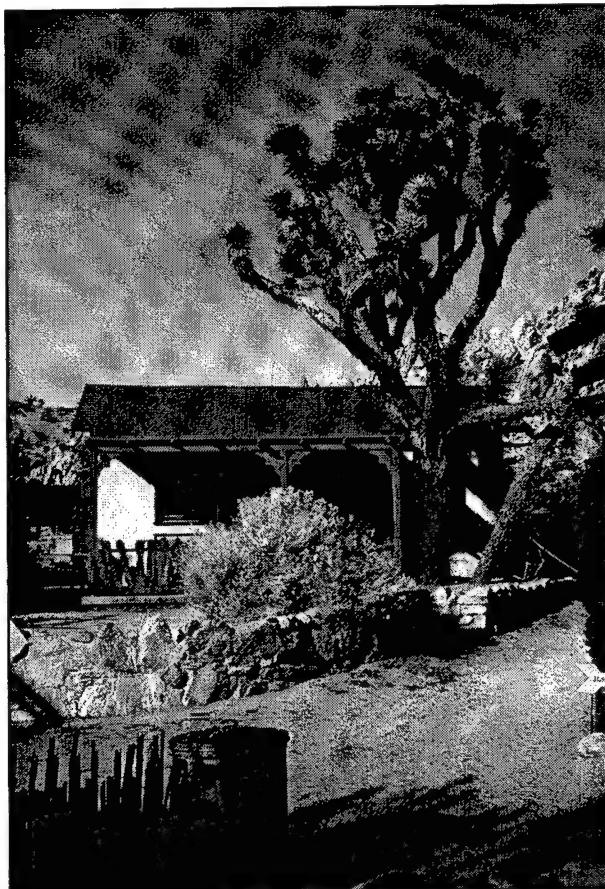
Repository 2 is a wood-framed cabin with a wood-shingled roof and a poured-concrete foundation. No renovations have been made to the structure. The plumbing and electrical systems are original to the structure. The wood-framed windows are approximately 2 x 2 feet (w x h) and are partially covered by venetian blinds; the windows show no signs of leakage.

Figure 39. Exterior view of Repository 2 at the Antelope Valley Indian Museum.

cabin interior. The collections storage room is cluttered with boxes of artifacts and open drawers stacked on top of each other.

Repository 2 does not have functional heating or air-conditioning systems. This structure also does not have monitors or controls for humidity. Light is provided by uncovered, nonfiltered incandescent bulbs and by natural light. Staff clean the building on an as-needed basis. Excessive dirt and dust were present in Repository 2 during the site visit.

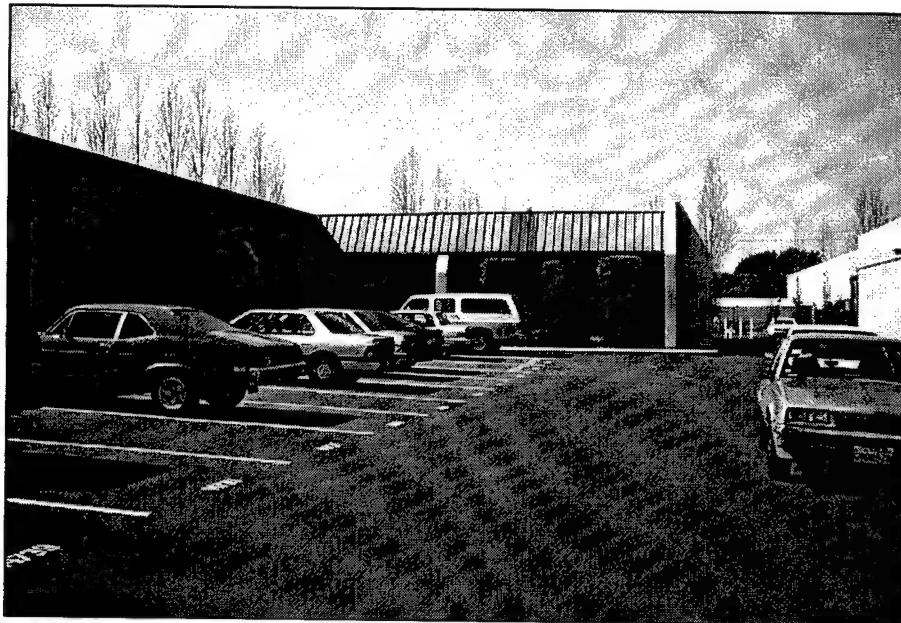
Basin Research Associates has office, laboratory, and storage space in a one-story office complex (Figure 41) in the Catalina Business Park, San Leandro, California. The firm occupies 2,680 ft² within the complex, which was built in 1985 and houses various businesses. Activity areas within the company include offices, a large multipurpose room that has temporary artifact storage areas, an artifact-processing area, a laboratory, a records-storage area, a materials-and-supplies storage area, and a loading dock. Access to the loading dock is blocked at the present time by field equipment. Work areas are also filled with excess office equipment and numerous artifact boxes.

Figure 41. Basin Research Associates offices are located in this industrial complex.

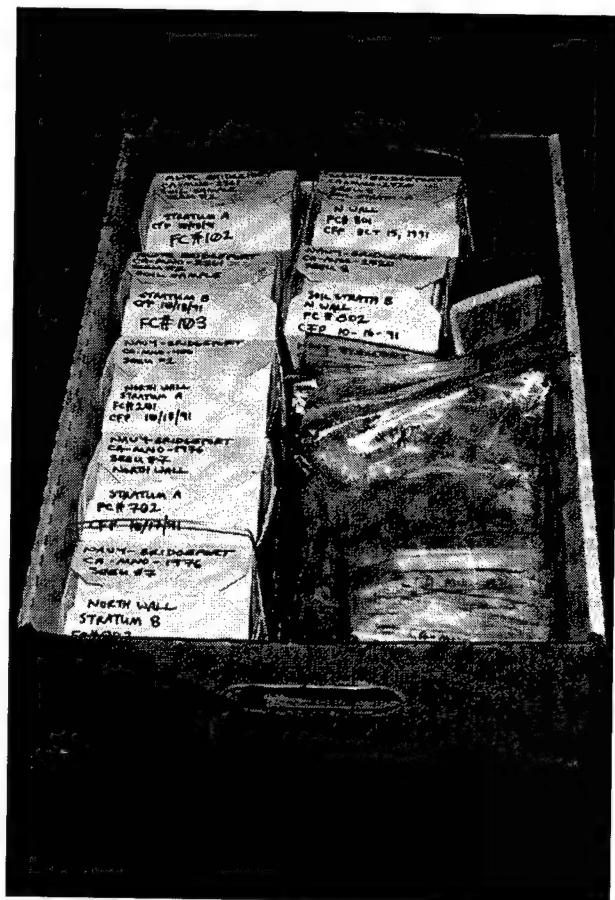
Secondary containers for NAS Moffett Field and the NASA Ames Project are acidic-paper boxes with folding-flap lids and wire handles; they are similar to carry-out food containers. Secondary containers for the MWTC Bridgeport Project include the same wire-handled containers (60%) and 2-mil, zip-lock bags (40%) (Figure 44). Soil samples are stored in the boxes, and lithics are stored in the zip-lock bags. Information on secondary container labels is in black marker, and includes the site number(s), material class, and the types of associated documentation in the box.

Figure 44. View of the primary and secondary containers that house MWTC Bridgeport collections at Basin Research Associates.

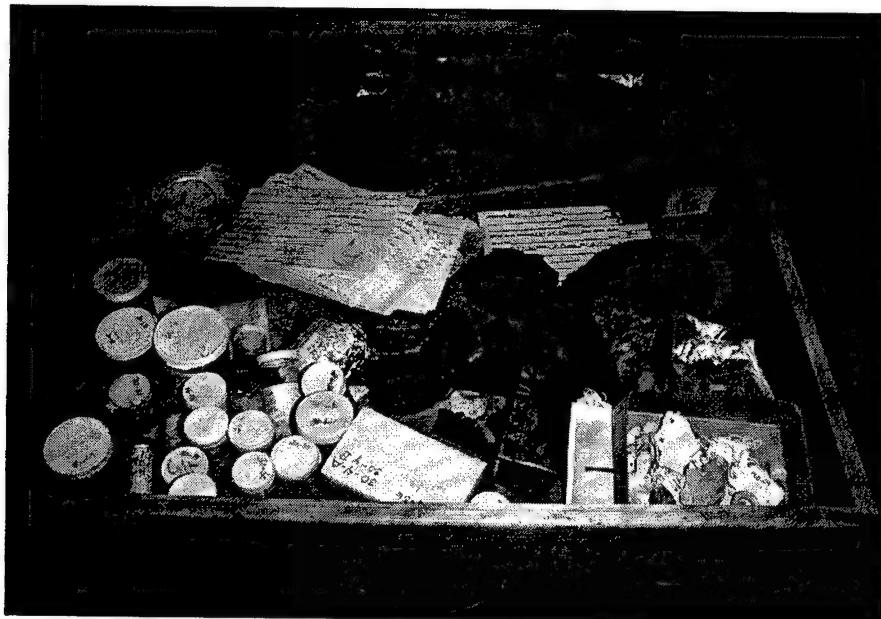
Most of the secondary containers in Collections Storage Area 1 have labels written directly on the container in marker or have acidic pieces of paper taped to the container. Some of the secondary containers in the classroom were not labeled.

Labels on secondary containers in Collections Storage Area 2 are either written directly on the container in marker, paper tags written on in ink and taped to the container, adhesive-paper tags written on in marker, paper slips written on in ink inserted in the container, or nonexistent.

Figure 51. Illustration of types of secondary containers—plastic vials, plastic bags, aluminum foil, and cardboard boxes—at CSULA.

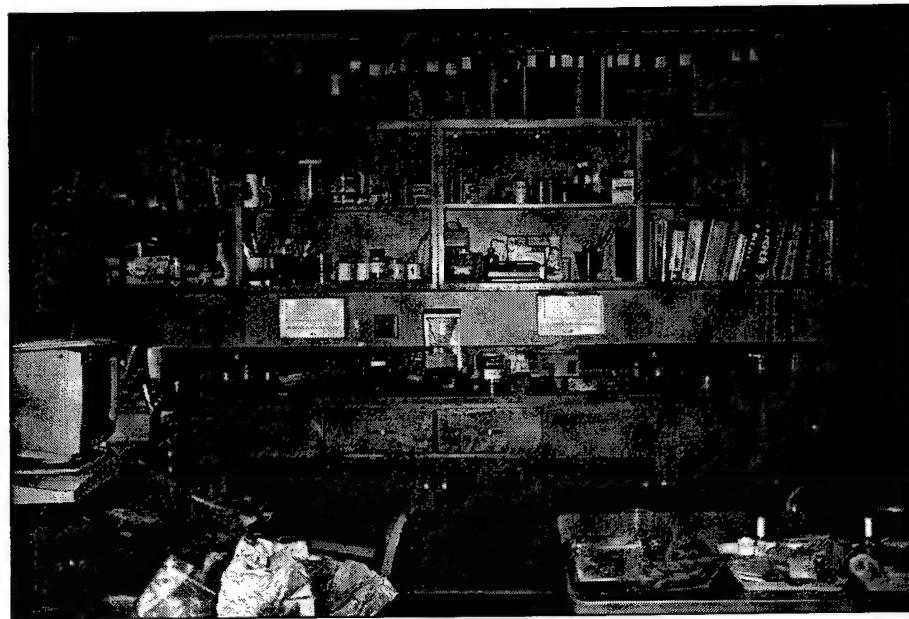
Figure 52. Associated records are stored in a portion of Collections Storage Area 1.

Most of the associated documentation, other than that currently being used by students, is kept in Collections Storage Area 1 (Figure 52). A total of 5.3 linear feet of associated documentation, including photographs and negatives, artifact cards, catalog sheets, level forms, field forms, reports, and slides is kept on the shelves in her office. Some of the photograph log sheets and other forms are kept on a shelf over the sink in the classroom.

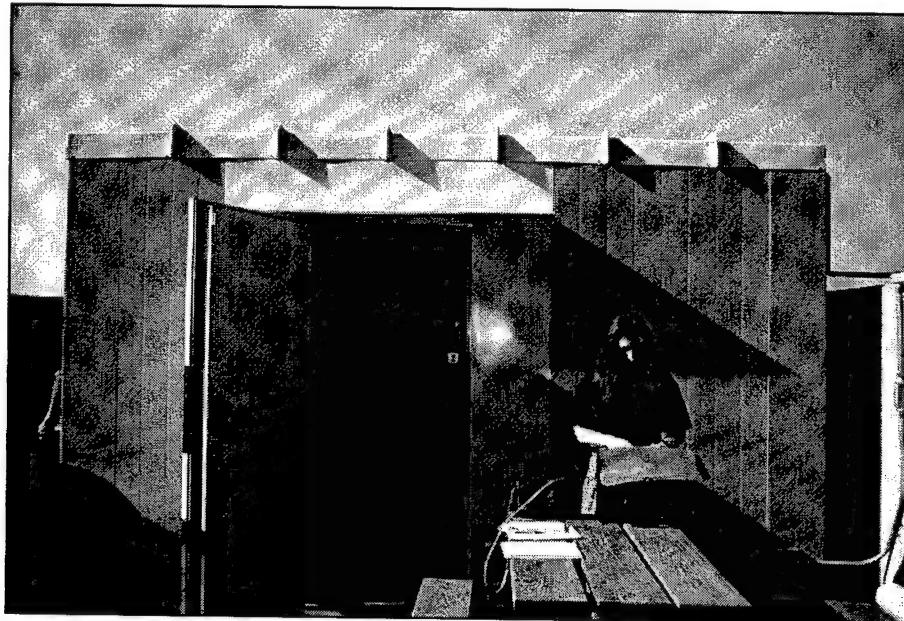
Figure 57. Exterior view of Repository 1 at CINP.

an insulated metal roof, a metal floor, and no windows. The single door is a hollow-core, metal-paneled fire door. The plumbing and electrical systems are original to the structure. A failure of the sprinkler system in September 1992 damaged some historical-period metal artifacts that were stored on open, metal shelving units. These non-Navy objects are currently at WACC undergoing conservation treatment.

Fire-detection devices present include a manual fire alarm on the exterior of the building, a smoke detector, and a heat sensor meant to trigger the sprinkler system, which is nonfunctional. The fire alarm is wired directly to the local fire department. There are no functional fire-suppression devices present.

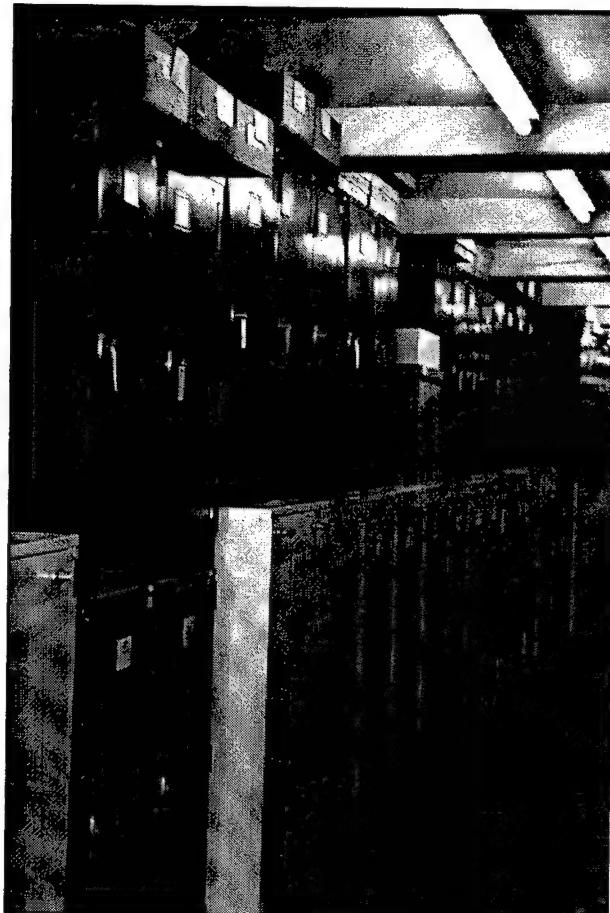
Figure 67. Stacked metal cabinets, lined with wood, house materials from San Nicolas and San Miguel Islands that are stored at NHMLAC.

1. To make more efficient use of space, install new space-saving cabinetry with adjustable shelves in Collections Storage Area 1 to replace the old units.

6. Develop an integrated pest-management plan that includes monitoring and control.
7. Replace storage units containing uncoated wood with proper cabinets. Uncoated wood poses the threat of outgassing and damaging the collections.
